RealSense™ Product Family

D500 Series

Specification Update

Revision 001

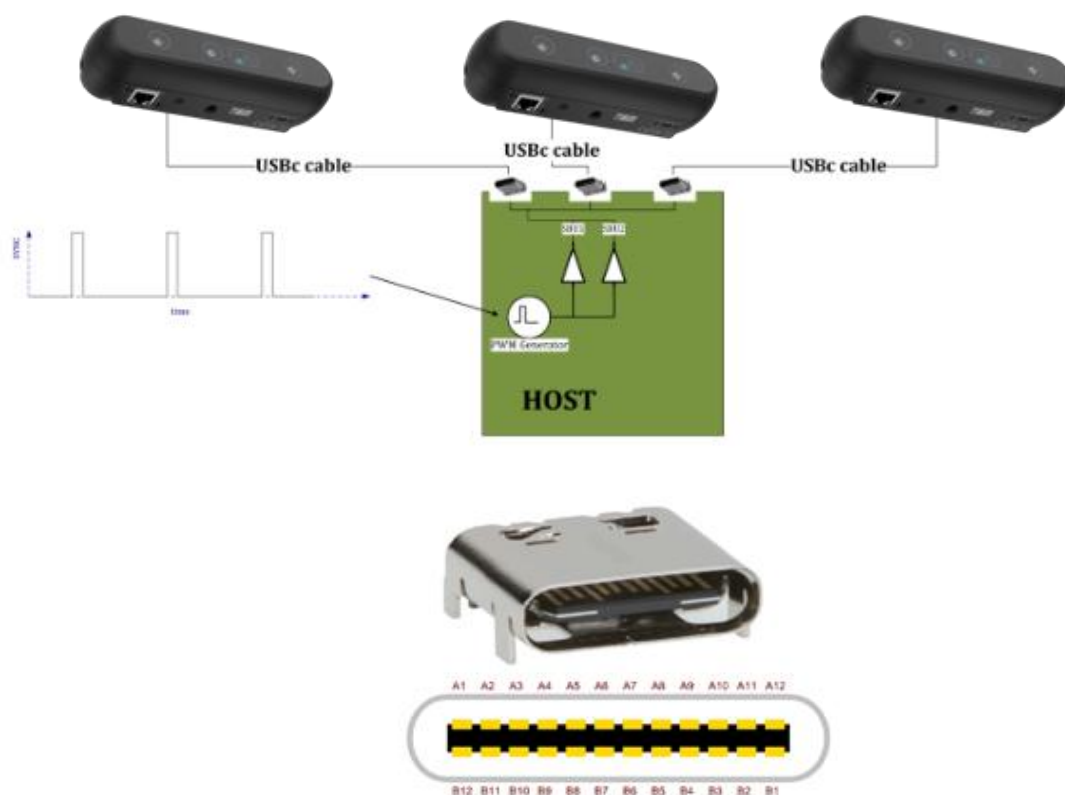
4.1 External HW Sync

| Number | Status | Errata |
|---|---|---|
| RSDEV-2744 | Open | External HW Sync is supported on HW, SW support is missing. Refer to Appendix |

- Multiple cameras can be connected to one host and will be able to stream asynchronously independent data
- The cameras can be hardware synchronized (HW sync) so they capture at exactly the same time and rate
- The host will be the synchronization master, and the cameras will be working in slave mode
- An SDK API will be used to configure the cameras in slave mode
- The main difference between the D400 (Vision Processor V1 and V3) HW sync and D555:
 - D400 cameras HW sync use the 9pin aux connector—pins 5 (SYNC) and pins 9 (Ground)
 - D555 will use the USB type C connector 2 SB (sideband) pins, requiring connecting a USB type C connector on the host side as well
- Note: The RGB color sensor is synchronized with the depth sensors (left and right) when they stream at the same FPS
